# The Perfect

# Pyramid:

## A Wonder in the Coatings World

Re-coating the Gold Pyramid House in northern Illinois with a custom-made volatile-free gold coating

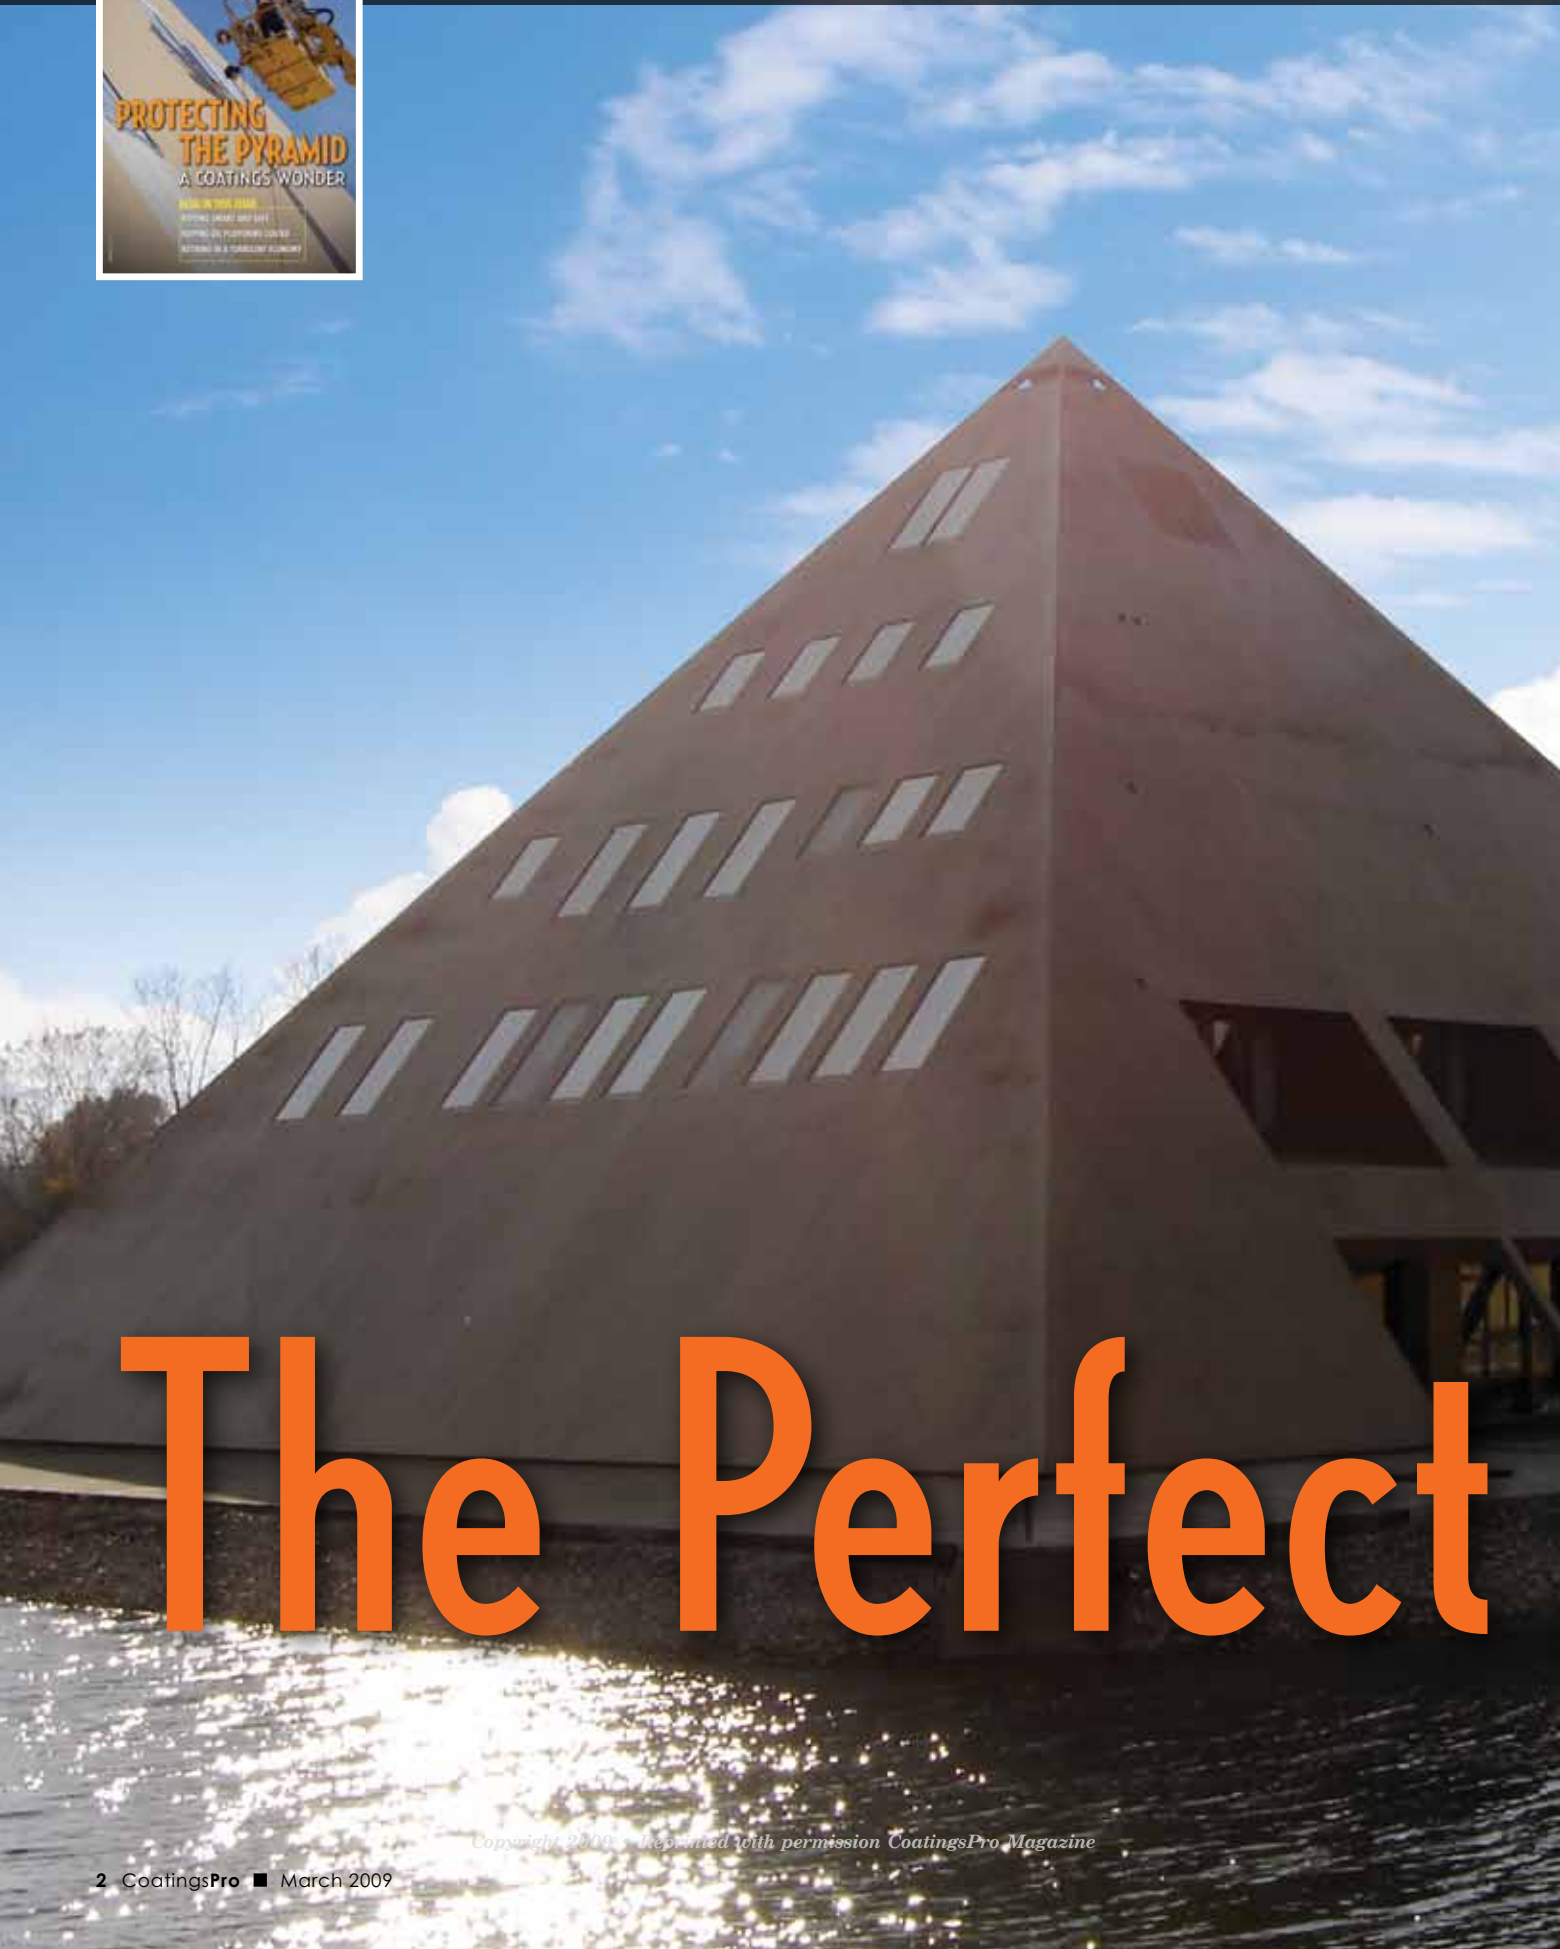
**ABOVE ▲** “When originally built, this house was covered in 18 karat gold plates,” Crowder says. “It had a coating underneath and the 18kt gold plates on top.” For 10 years, they’d had problems with a couple of windows leaking. And the windows were the house’s source for thermal shock. “When the sun shines down on the window glass, it’ll heat up about 150 degrees and drop about 40 or 50 degrees when the sun goes behind the clouds.”

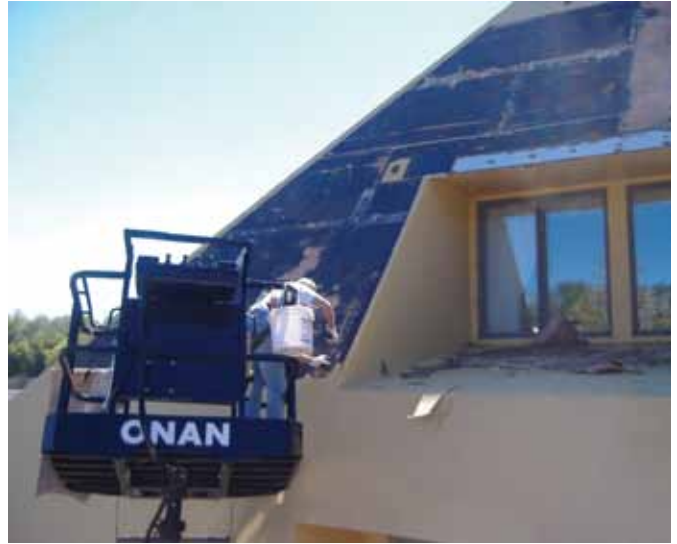
**ABOVE ▲** Because the sides of the pyramid-shaped building taper in at the top at a 45-degree angle, anything above shoulder-height was reached with a man lift. The PPC team worked two Haulotte lifts with two sprayers in each basket. “The shape of the building caused a challenge in moving the ‘man lift’ in a smooth and efficient manner in order to facilitate proper spraying of the coatings,” explains Holsen.

Because the sides of the pyramid-shaped building taper in at the top at a 45-degree angle, anything above shoulder-height needed to be reached using a man lift. To cover more ground at once, the PPC team worked two Haulotte lifts with two sprayers in each basket. To run the machines, they used a Cummins Onan (unrelated to Jim) three-phase generator and a MMD Airman 185 air compressor. The plan was set. The execution, however, was a bit more difficult than it looked on paper.

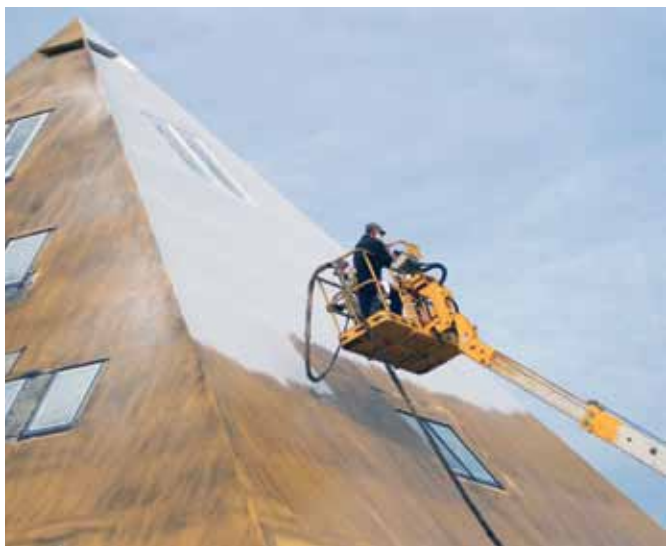
**ABOVE ▲** When working in the lifts, all four men wore DBI-SALA and Rose Pullover harnesses 100% of the time. Before scaling the pyramid each morning, they first inspected their safety gear to ensure everything was correctly fastened and properly clipped onto the lifts.

To ensure the safest job site, all four men in the lifts wore DBI-SALA and Rose Pullover harnesses 100 percent of the time. They double-checked their harnesses each morning to ensure everything was hooked up correctly and clipped onto the lifts.

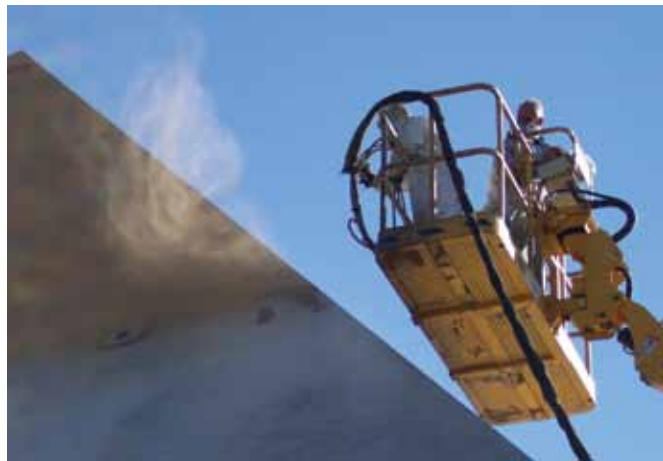
**ABOVE ▲** “Wind was a big problem because of the way it swirls around the building,” Crowder says. “At 20' off the ground the wind would be blowing one way and up 20' higher the wind would change the other way. I've never worked on anything so hard in all my life! Even when doing water tanks the wind direction stays constant with you; but being on the pyramid like that, the wind direction changed one way to the other.”

“Wind was a big problem because of the way the wind swirls around the building,” Crowder says. “At 20 feet off the ground the wind would be blowing one way and up 20 feet higher the wind would change the other way.” These quick changes in airflow pattern made it hard for the crew to apply the coating evenly. All coating precedents went out the newly-sealed windows.

“I’ve never worked on anything so hard in all my life!” Crowder exclaims. “Even when doing water tanks the wind direction stays constant with you; but being on the pyramid like that, the wind direction changed one way to the other.” The wind added to the angle of the pyramid meant this job, just north of the

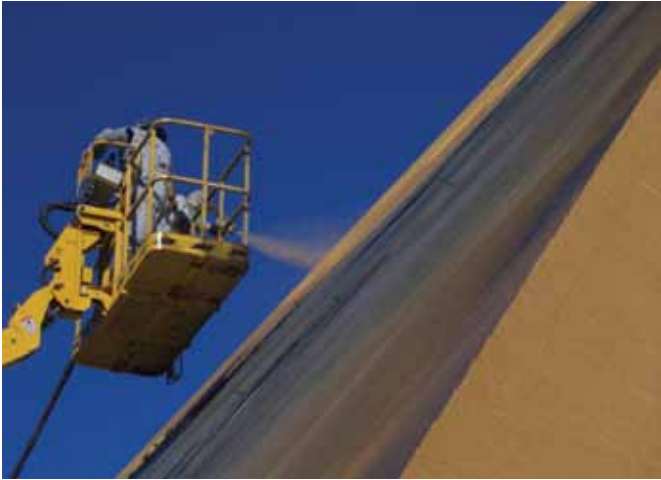
**ABOVE ▲** The crew first spray-applied a flash coat of VFI-1007 primer in a 1- to 2-mil pass using a Graco airless spray pump with a 415 tip. Then they applied a different primer — VFI-2760 glass primer — directly to the windows. This primer — applied in a 2-mil thickness on top of the urethane caulking — acted as a second seal. This was followed by a spray-applied 30-mil basecoat of VFI-540 and another layer of the VFI-1007 primer. The second primer was specified to ensure a good bond between the basecoat and topcoat. This was followed by the golden 20-mil topcoat of VFI-277 and a 6-mil, roller-applied clear coat of VFI-2575.

They started with a flash coat of VFI-1007 primer. In four hours, they applied a one-to-two mil pass using a Graco airless spray pump with a 415 tip.

“One side a day was what we were trying to get done, but there was other detail work that we had to do.” This included applying a different primer — VFI-2760 glass primer — directly to the windows. This primer — applied in a two-mil thickness on top of the urethane caulking — acted as a second seal. In Crowder's eyes, this second seal was the most important one.

When they returned to spraying the basecoat, they used a Glascraft MXII and Graco Foam Cat 400. They used a Probler gun with a 02 tip to achieve 30 mils. It took the crew six days total to apply the basecoat and a few minutes for it to dry to the touch.

They came up with VFI-277, which the PCC crew spray-applied at 20 mils with the same equipment they used for the basecoat. It took the crew six days to apply the gold topcoat, a few minutes to dry to the touch, and 18 hours for a full cure.

Then, to finish the pyramid, the crew topped it off with six mils of the VFI-2575 clear coat. They roller-applied the clear coat on with a half-inch Purdy nap roller. The clear coating was used to extend the life and enhance the shine of the gold topcoat. The crew learned that it would also help bird droppings wash off with rainwater as well as help get snow to slide off the building.

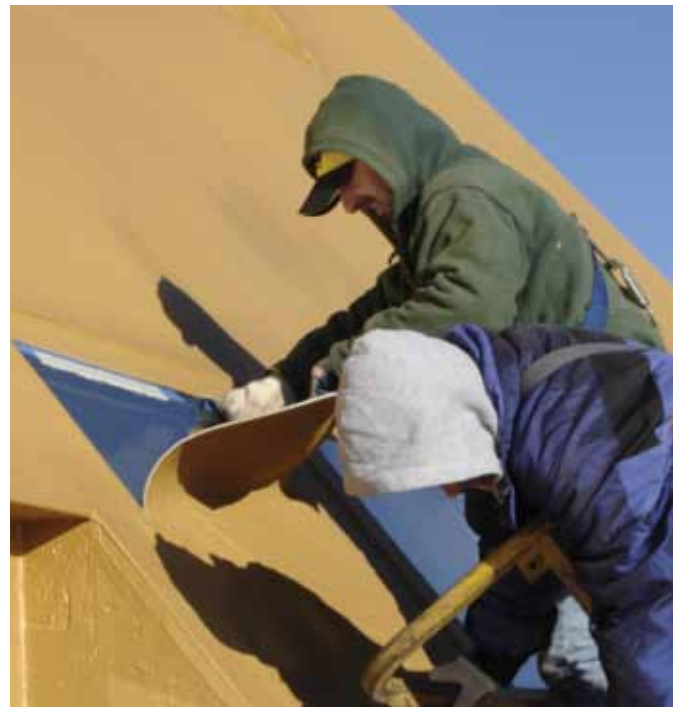
**ABOVE ▲** Once the topcoat completely cured, the crew pulled the Langeman’s wire tape from the windows and doors. This removed excess coating while maintaining a tight, clean seal around the windows. “And now the snow slides off and it stays nice and clean,” Crowder says.

The combination of slow curing topcoat and heavy morning dew provided the crew with a tight six-hour work window in which they had a lot to accomplish. Once the topcoat completely cured, however, the crew pulled the Langeman’s wire tape from the windows and doors. This removed excess coating while maintaining a tight, clean seal around the windows.
