# Water Tanks Treated

The Lake County Public Water District decided that their two holding tanks, which had been without maintenance for 20 years, needed to be updated. The water treatment plant — located near the shore of Lake Michigan — is capable of supplying 6,000,000 gallons of drinking water a day to Zion, Winthrop Harbor, and the Illinois Department of Natural Resources. With that many whistles to wet and a failing coating system, it should be no surprise that the plant decided to re-insulate and recoat their two 200,000-gallon solid contact units, or water tanks, clarifier control building, and catwalk between the tanks.

Re-insulating two 200,000-gallon tanks at the Lake County Public Water District

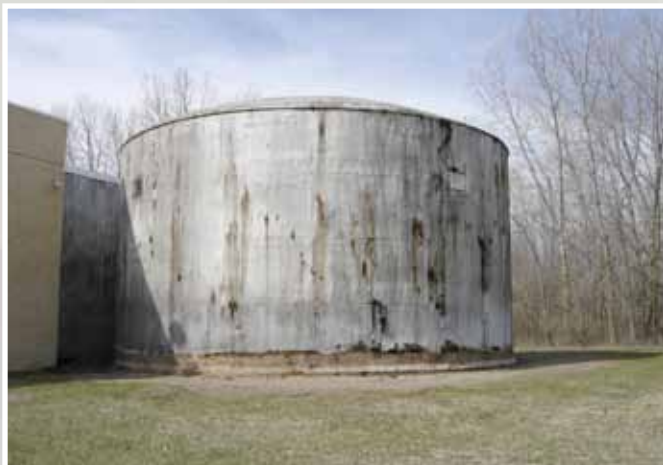
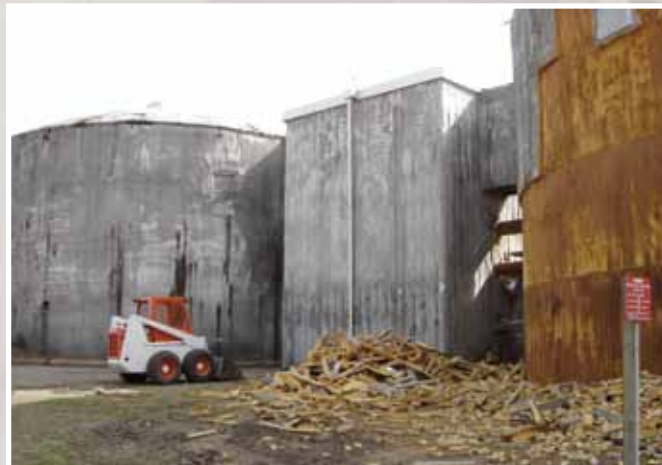
The first step for PPC's four-man crew was to remove the old, damaged insulation. When the crew arrived on the jobsite, the plant had dug out the bottom 4' of soil surrounding the tanks so that the crew could access the entire surface. To expose the steel, the crew cut 3"-wide strips of the old insulation and pulled them off the tanks. It took the crew a week to remove all of the old foam, and took nine 30-yard Dumpsters to dispose of the waste.

"The hardest part of the job was stripping off the old foam," PPC's Vice President, Terry Crowder, said. To do this, they had to cut the foam in three-inch-wide strips with a Sawzall and then peel it off the steel. It took the crew a full week to remove the old foam completely. This was largely due to the height of the tanks.

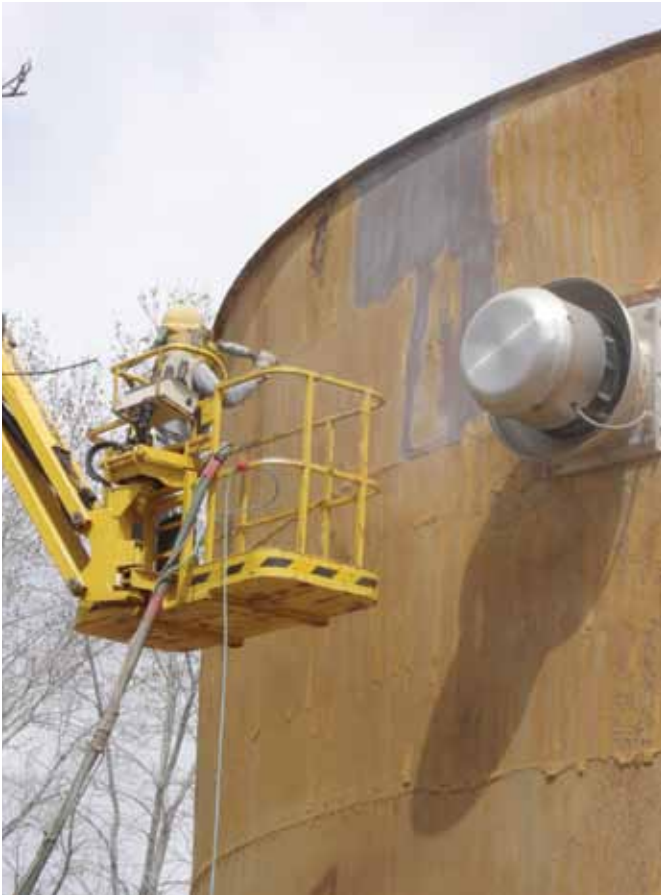
Much of the difficulty on this jobsite came from the height of the tanks. At 40' tall, each layer needed to be completed while on lifts. This meant that the crew had to wear proper safety gear the entire time. Both the sprayers and helpers wore harnesses beneath their Tyvek suits while working on the lifts. They also wore either full-face respirators or respirators and goggles, depending on the job. With almost the entire 16,000 square foot job completed off the ground, safety was crucial.

At 40-feet tall, everything — from the stripping of the old insulation to spray-applying the coating on the tanks, control building, and catwalk — had to be done while on lifts. The crew used two Houlette lifts (with two men on each lift) to reach the tops of the tanks. With roughly 16,000 square feet to re-insulate, the PPC crew decided upon a simple strategy: Strip one tank while spraying the other. This meant working both tanks at one time, but on different stages. Working the tanks simultaneously meant PPC was able to avoid wasting any downtime, which also meant that coordination was key.

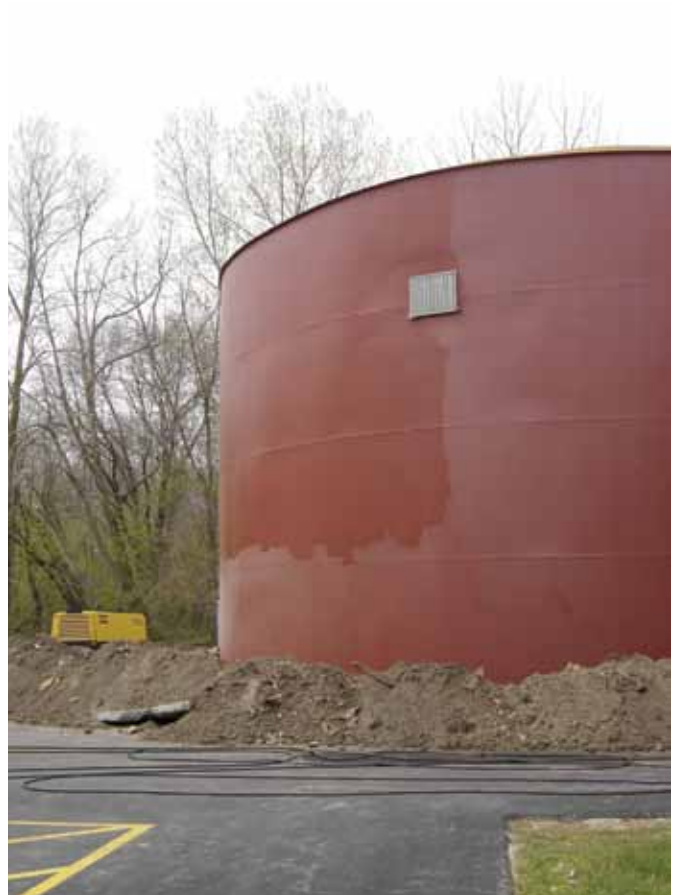
The PPC crew then came in and applied Volatile Free, Inc.'s (VFI) 1003 moisture cure primer at 6-8 mils. They achieved the thickness of the primer in one pass with a Graco airless spray pump and 415 tip. The crew traveled around the tanks blasting and priming one section at a time until the entire surface was completely covered with red primer. Compared to removing the old insulation, this stage was a breeze...even while working two tanks at once.

Each morning, after the dirt was cleaned off the tanks, the crew chose one area to attack. Depending on the wind, they chose a section that they knew they could finish — blast and prime — in one day. They used Black Beauty abrasive blast to remove all of the leftover rust on the substrate. With that area prepped, the crew then applied the primer to the blasted steel. They used the Volatile Free, Inc., (VFI) primer as a rust-inhibitor, which, after the results from the tanks' first coating system, was used to make sure everything was done to repel rust from forming on the steel surface. The VFI 1003 moisture cure primer was applied at six to eight mils in one

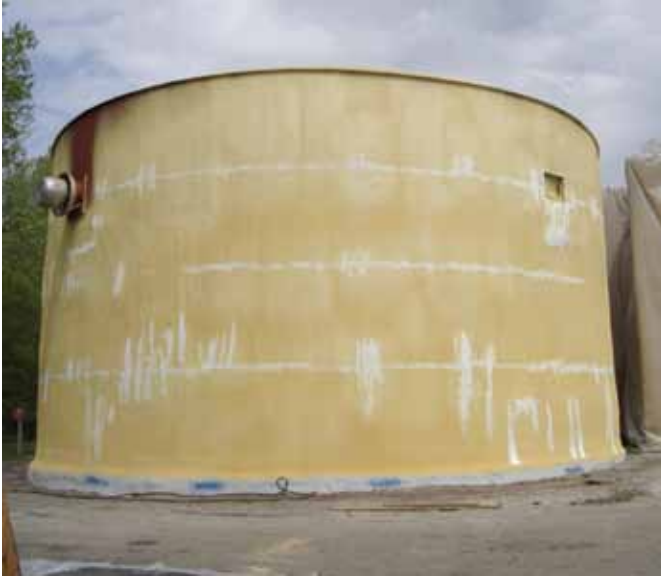
Before the crew could spray-apply the tanks with SPF, they first needed to hang tarps on the treatment building. Sitting a mere 10' away, overspray was a real concern. They used clamps to secure the tarp to the building. To protect the plant employees' cars in the nearby parking lot, the SPF crew coordinated their spray schedule with the plant's work schedule. Luckily, with only four employees working at the plant each day, coordinating a changing parking location was manageable.

Although the PPC team figured out a strategy that worked for their application process, the layout of the treatment plant still remained a challenge. With such a small area to work in, the SPF crew was concerned about overspray. With a mere 10 feet between the water tanks and treatment building, the working conditions at times were tight. To accommodate the proximity of the treatment plant, the crew made sure to cover the facing

side of the building with a plastic tarp while spraying. They hung the tarp with clamps to secure it to the building. This helped to ensure that the treatment building's appearance would achieve PPC's standards.

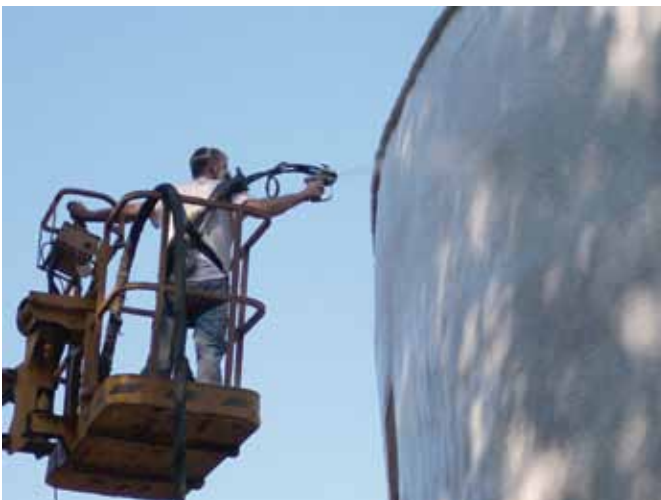
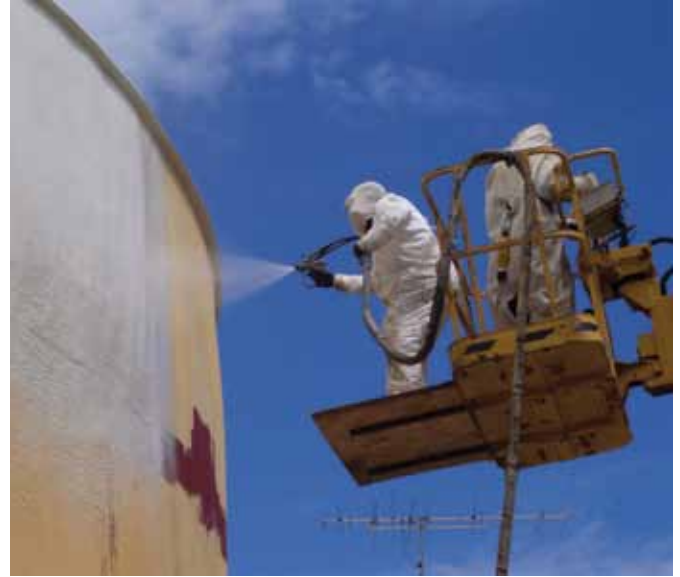
The spray foam — VFI 730 — enabled the insulation to reach every crevice of the tanks. To do this, the crew used a Gusmer 1600, FoamCat, and Probler guns, and a .02 tip. They sprayed 2.5" onto the entire tank. Then, to protect the SPF from UV damage and to make the surface tacky, the crew applied a flash coat of the 1003 primer. Before the basecoat went on, the PPC crew grinded any high spots around the tanks, including the seams. This assured that the tanks would receive a smooth and uniform finished look.

By spray-applying the insulation, the foam was able to conform around the arches of the substrate. This allowed the PPC team to insulate the tanks with a gapless system, which helped to accommodate the need for a surface that wouldn't allow condensation to collect. With 160 feet of hose, the crew sprayed two-and-a-half inches of SPF to the rest of the tanks.

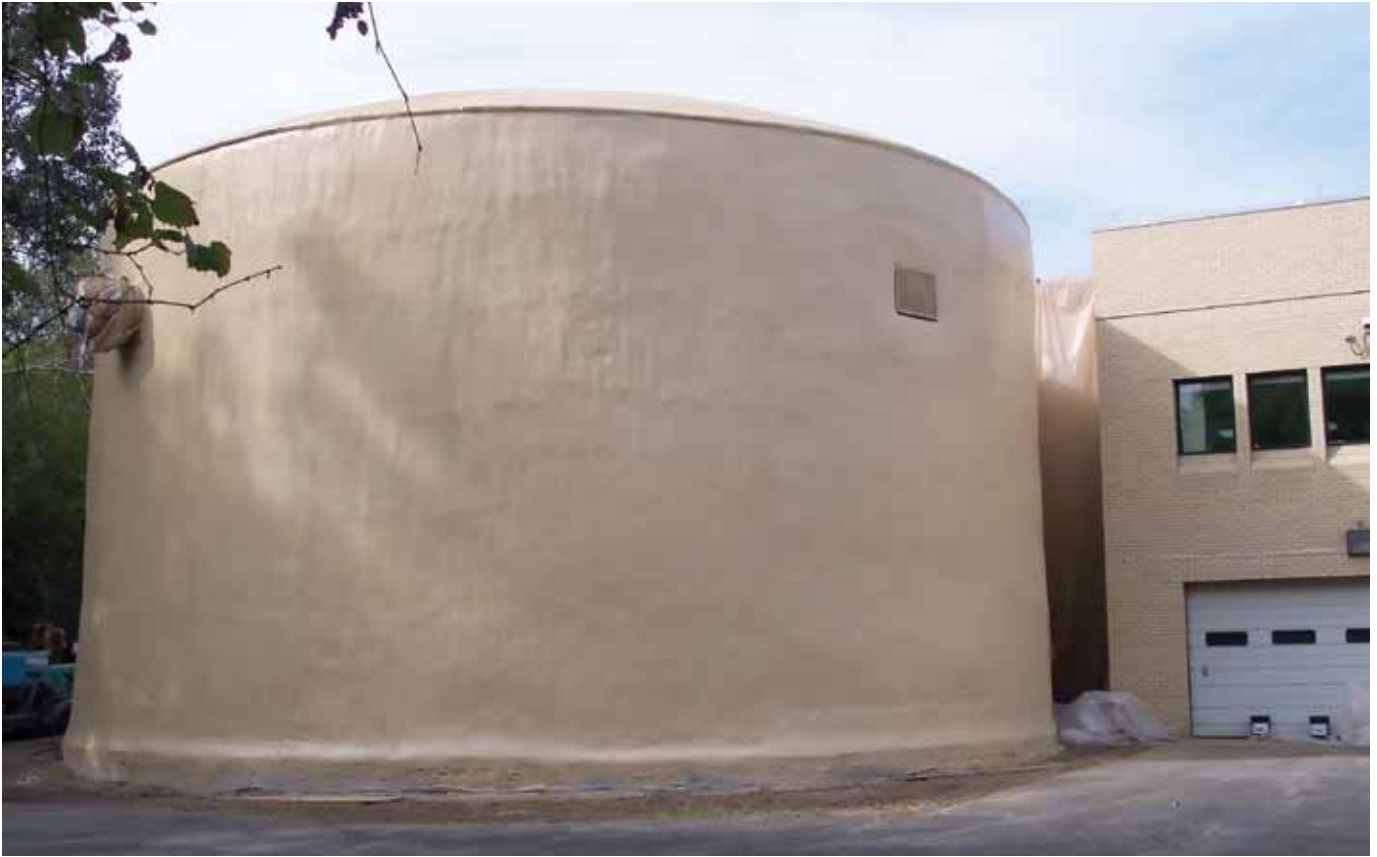
The topcoat was VFI's 277, custom-mixed a beige color to match the water plant's façade. The PPC crew applied 12 mils of the topcoat before dropping the overspray drapes and heading home. With all four steps — primer, SPF, basecoat, and topcoat — of the insulation system complete, the tanks should last for years to come. All in all, this coating "upgrade" was a success for Premium Protective Coatings, the Lake County Water District, and the surrounding towns.

As far as Crowder was concerned, the VFI 277 beige topcoat — which went on at 12 mils — gave the tanks a necessary "upgrade." Not only did the crew get rid of the old, off-white finish that was originally on the tanks, they also achieved a near-perfect match to the treatment building next door. It seems that the old coating system wasn't just ineffective after 20 years; it was also unattractive!
