# SEALING: GOLDEN OPPORTUNITY

## RE-FINISHING SCHOOL'S MEDITATION DOME

Re-roofing the Maharishi Patanjali Golden Dome in Fairfield, IA.

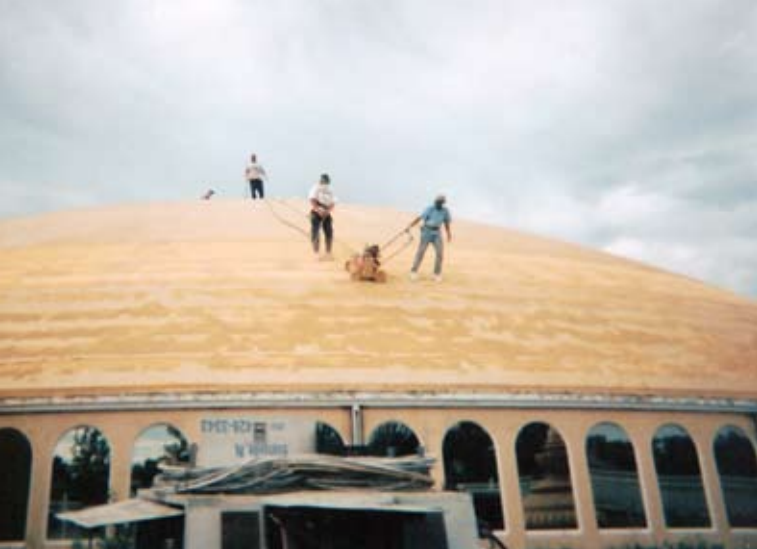
The protective tarp allowed the team to scarify the entire 25,000 sq. ft. roof without worry that the debris would endanger anyone underfoot. To scarify, the Thermoseal team used a reel-type roof scarifier with a West Equipment carbide tip. They affixed both the machine and the workers to the rooftop with tie-off attached with 3/8" braided steel wire cable to the collar at the top of the dome. Starting at the bottom and working their way to the top, the crew slightly shortened the wire cable after each pass to ensure a tight hold.

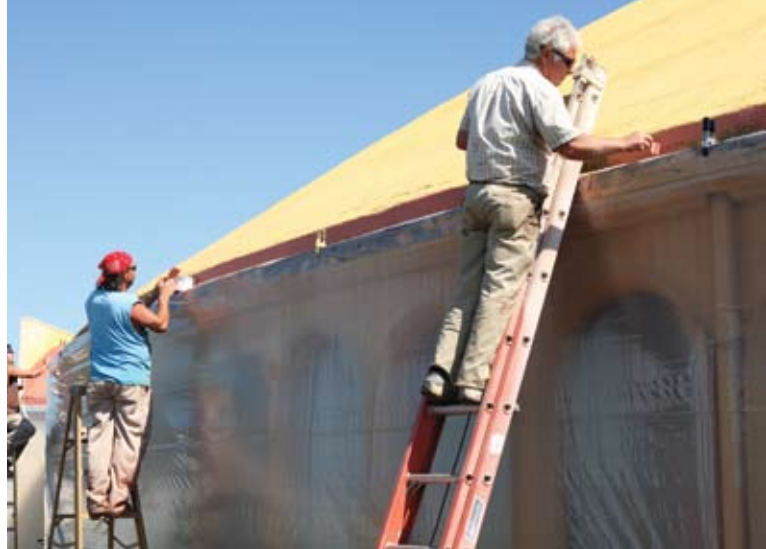
Re-finishing the Golden Dome would require a number of separate steps. First, the Thermoseal crew closed off the building from foot traffic. Not only was no one allowed in or out of the building, but the area around the building was secured with a warning line as well. With the building secure of foot traffic, the team encircled the building with tarps taped to the roofline.

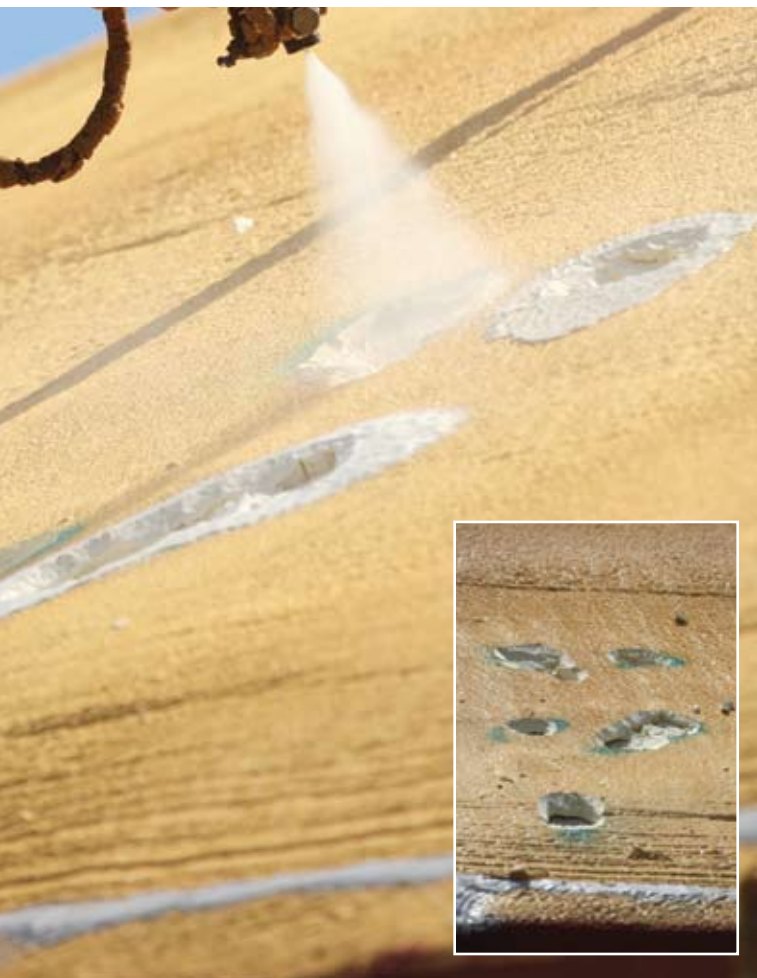
Once the roof was scarified, the team was able to locate and fill areas of deteriorated foam that were a result of lack of attention and maintenance. Though the Patanjali Golden Dome roof had been re-foamed a few times over the years, it hadn't been completely re-finished since being built in 1979. David Cates, Thermoseal's President, explains that the crew "identified, tore out, and replaced areas of deteriorated foam" (see insert).

but this was the first time it was renovated with scarifying and re-foaming. David Cates explains that they "identified, tore out, and replaced areas of deteriorated foam." Once the dome was prepped, the spraying could begin.

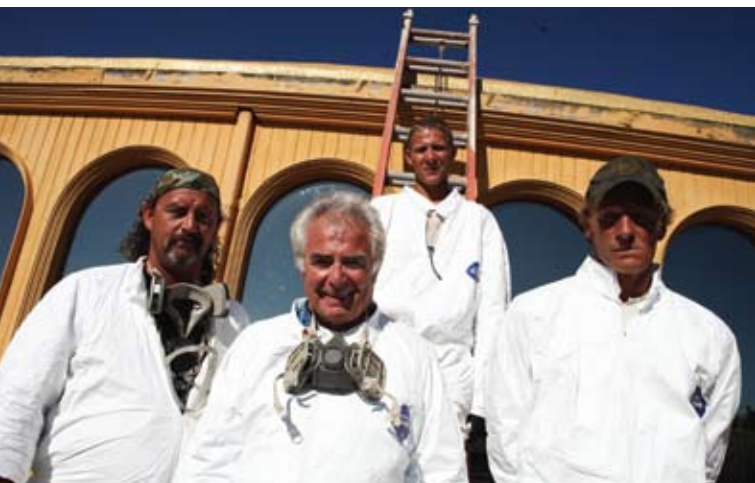
To protect themselves from the chemicals, the crew wore 3M organic vapor, dual carbon-filter respirators, Tyvec suits, and wrap-around tinted safety glasses. At the beginning of each week, Julian Cates held a “tool box” meeting to discuss re-fueling equipment, ladder safety, fall protection, PPE, lifting, weather concerns, and safe methods of using the compressed air. With a job like the Golden Dome, safety was imperative.
